CT-699
THOMAS MCCREADY LOG HOUSE

Cove Point
Private

State Historic Sites Inventory Form

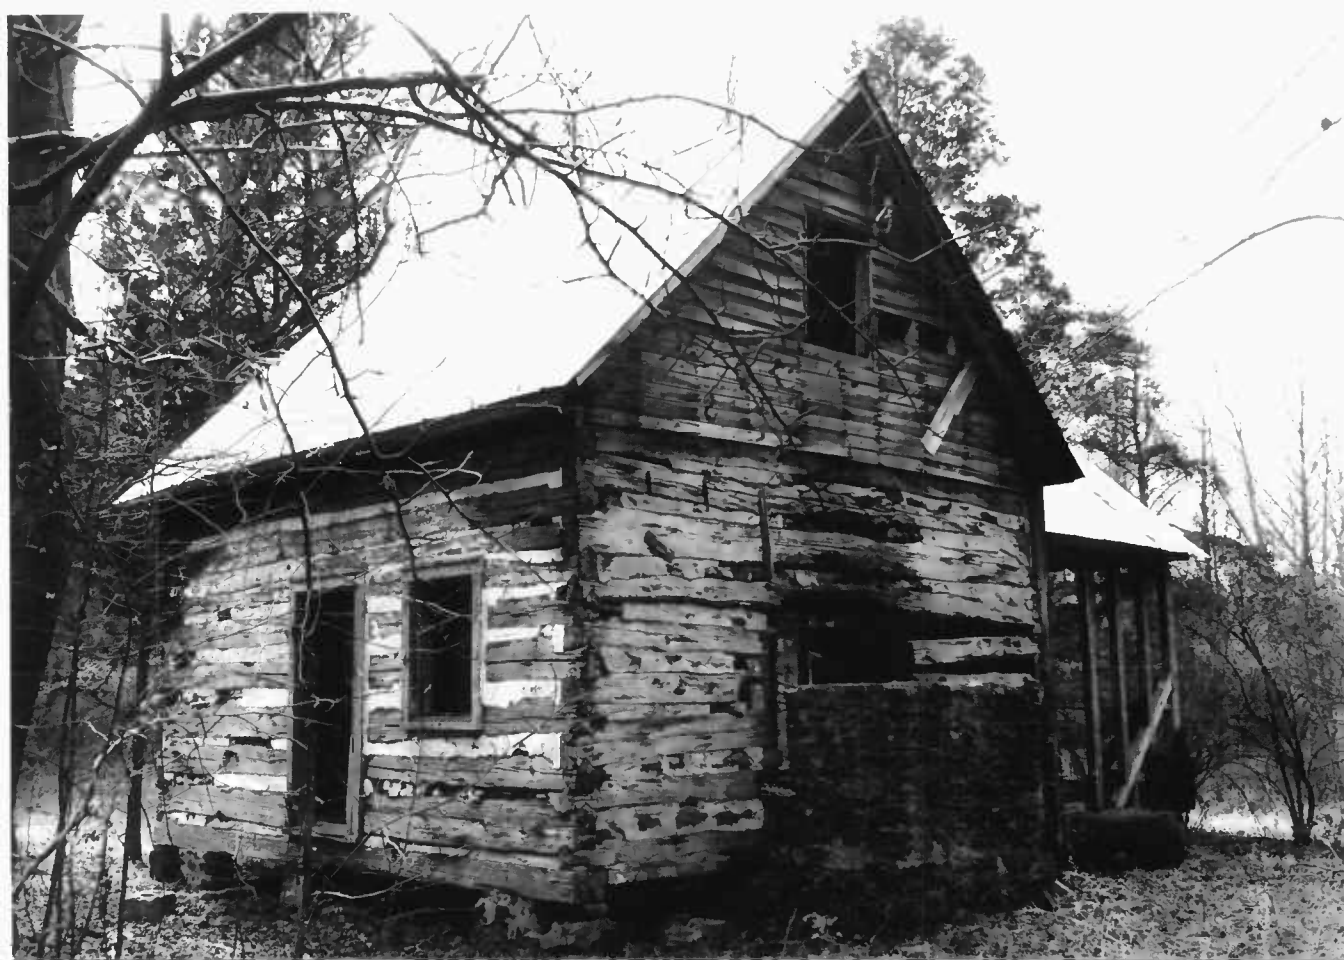
CT-699
Thomas McCready Log House
Little Cove Point Road
Cove Point
Calvert County, MD
E & N

On the east facade of the building, facing the road, there is a door opening in the center bay and a window opening in the north bay. A large sandstone chimney is centered on the north gable wall. Fallen brick rubble in the vicinity of the chimney suggests that the upper shaft of the chimney was constructed of brick. A window opening in the center of the upper gable conflicts with the chimney position, and presumably dates to the later alteration. The only opening in the west facade is a single door that opens into the later frame wing.

This one story, two bay log house is joined by a similar-sized frame section at the rear. The east-facing house features a left-hand entrance. The remains of an exterior chimney built of local composite fieldstone exist at the north end.

The V-notched logs are chinked with stone. Lapped weatherboards sheath the gable ends. Metal sheets cover the roof. The house stands on piers of fieldstone and brick.

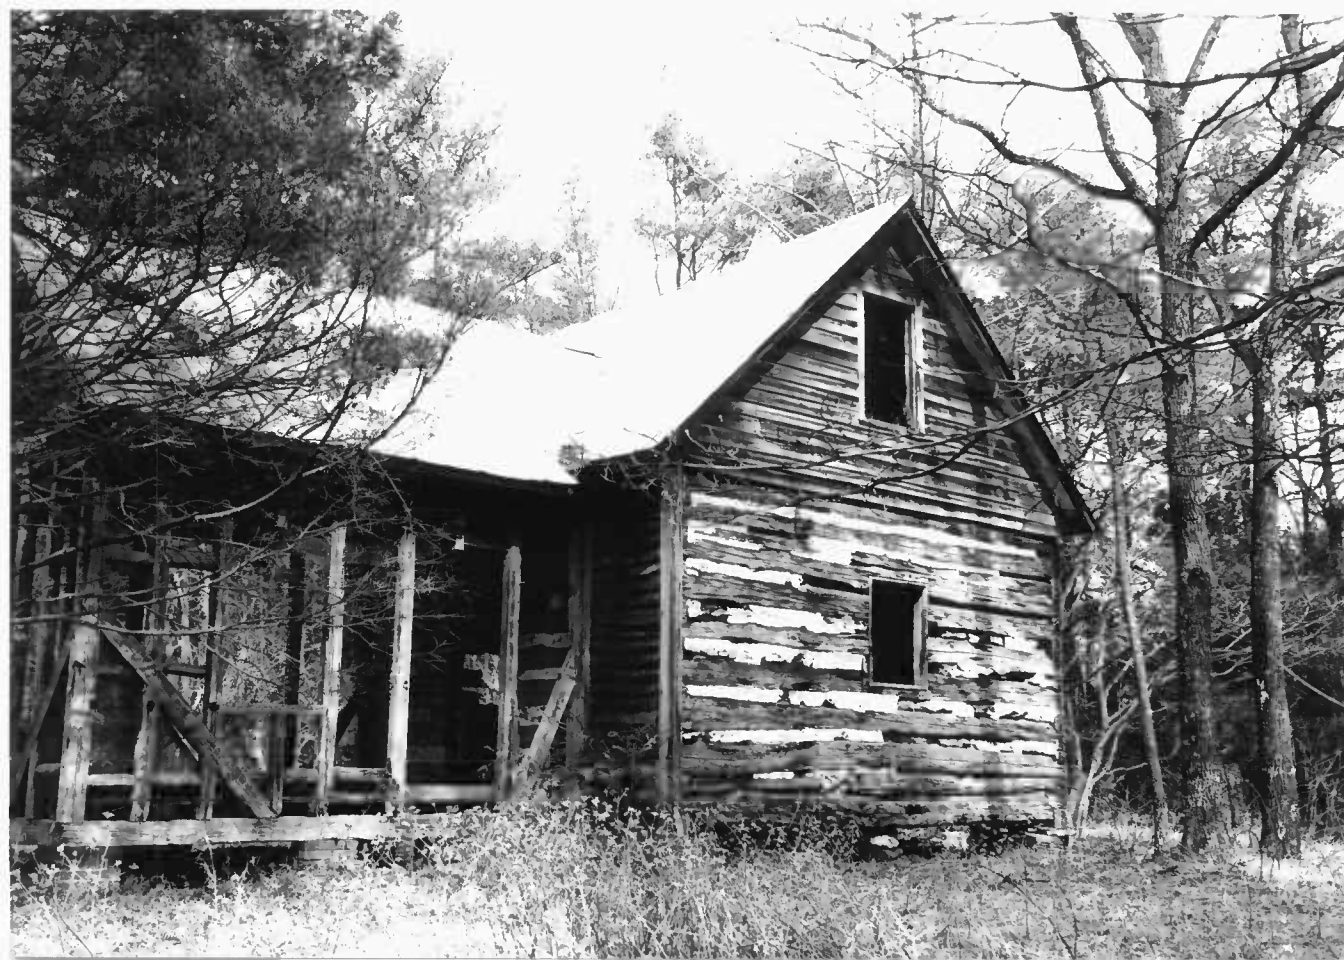
CT-699
Thomas McCready Log House
Little Cove Point Road
Cove Point
Calvert County, MD
WIS

A single window opening is centered in the first story and in the upper gable of the south gable wall.

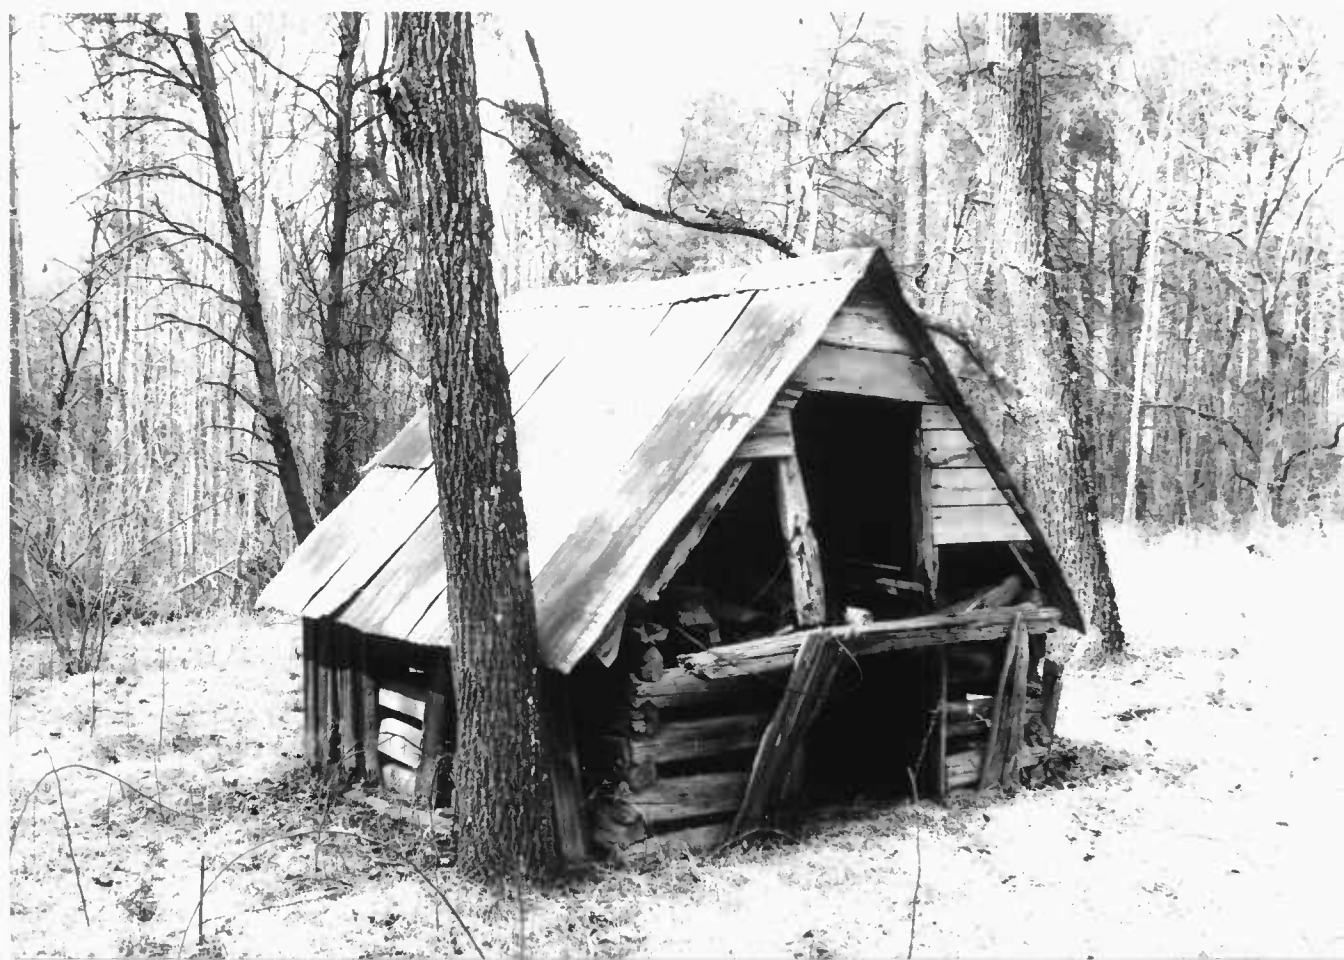
CT-699
Thomas McCreedy Log House
Little Cove Point Road
Cove Point
Calvert County, MD
outbuilding
S&E

Outbuilding: An extremely small outbuilding approximately 30 yards to the south of the house was probably used as a poultry house or for pigs. It is 8'-4" by 7'-0", of log construction, with a shed roof that slopes from a height of 3'-6" at the front (south) down to a height of 2'-6" at the rear (north). The shed pitch is accomplished simply by using four logs for the rear wall and six logs for the front. The logs are joined at the corners with V-notching, and have been covered with plain, vertical board siding. A door in the east wall is the only opening.

A small log outbuilding stands southwest of the house.
